**DEPARTMENT OF TRANSPORTATION**

Contract #: 04-0120F4Cty: SF/ALA Rte: 80 PM: 13.2/13.9File #: 69.28**WELDING INSPECTION REPORT****Resident Engineer:**Pursell, Gary**Address:** 333 Burma Road**City:** Oakland, CA 94607**Report No:** WIR-013121**Date Inspected:** 14-Apr-2010**Project Name:** SAS Superstructure**OSM Arrival Time:** 700**Prime Contractor:** American Bridge/Fluor Enterprises, a JV**OSM Departure Time:** 1900**Contractor:** Zhenhua Port Machinery Company, Ltd (ZPMC), Changxing Island **Location:** Shanghai, China**CWI Name:** Li Yang and Wu Zhi Cheng**CWI Present:** Yes No**Inspected CWI report:** Yes No N/A**Rod Oven in Use:** Yes No N/A**Electrode to specification:** Yes No N/A**Weld Procedures Followed:** Yes No N/A**Qualified Welders:** Yes No N/A**Verified Joint Fit-up:** Yes No N/A**Approved Drawings:** Yes No N/A**Approved WPS:** Yes No N/A**Delayed / Cancelled:** Yes No N/A**Bridge No:** 34-0006**Component:** OBG Trial Assembly**Summary of Items Observed:**

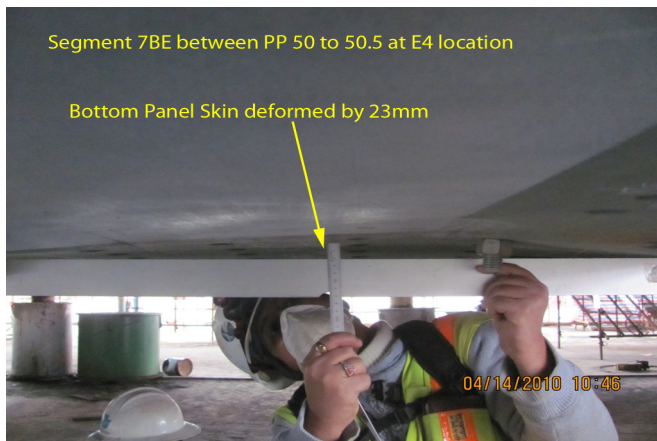
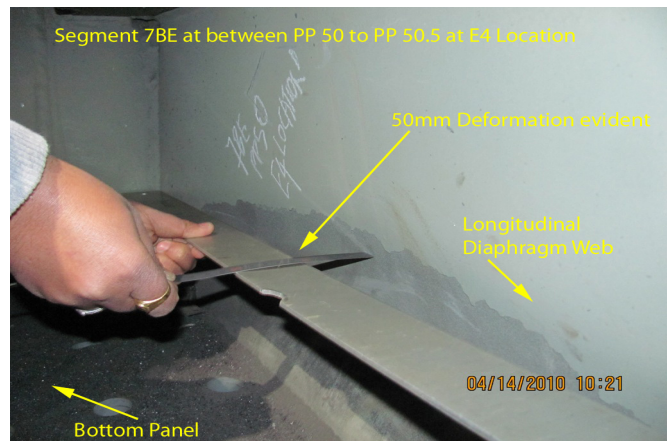
The QA inspector prepared Punch List for the skin flatness for Bottom Panel between PP 50 to 50.5 and observed 23mm forwarded the punch list to lead as well to the engineer for review and further action. Please refer the pictures attached for more comprehensive details.

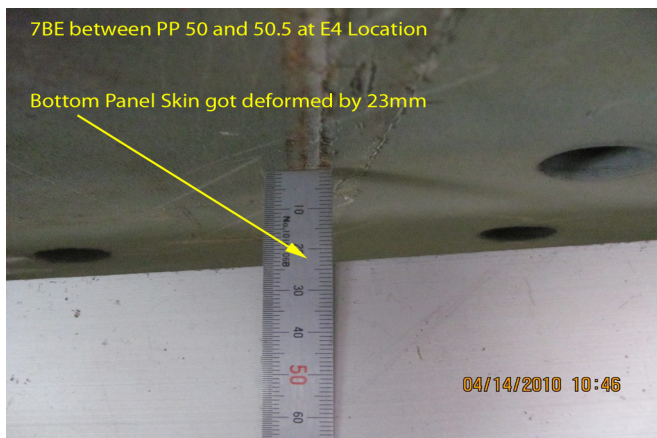
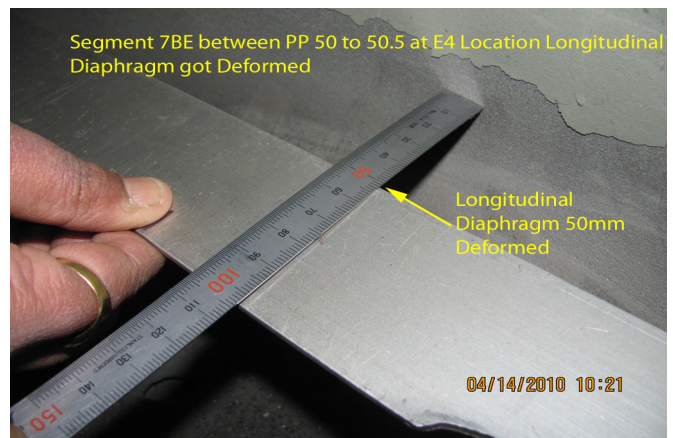
The QA inspector prepared Punch List for the Longitudinal Diaphragm (LD) web deformation between PP 50 to 50.5 and observed 50mm forwarded the punch list to lead as well to the engineer for review and further action. Please refer the pictures attached for more comprehensive details.
